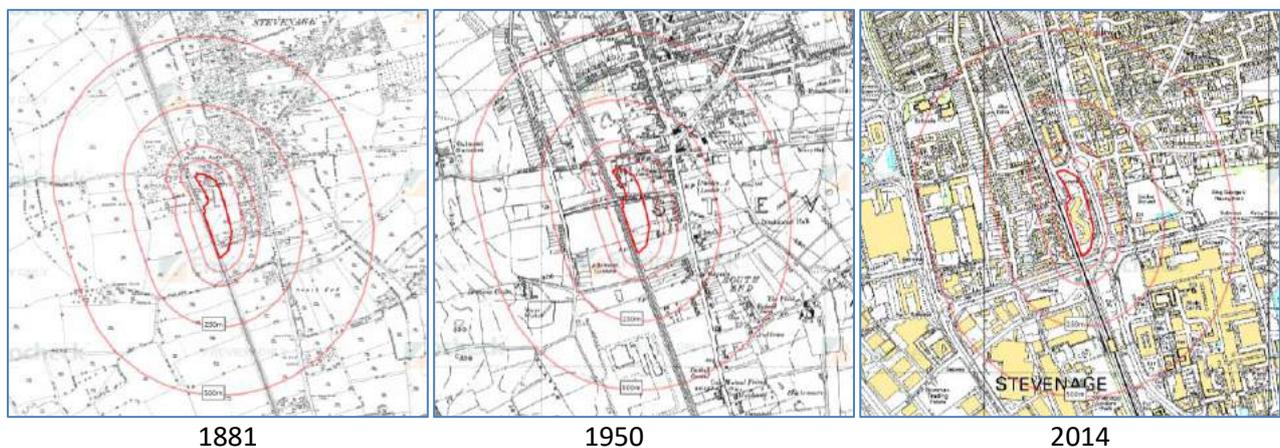
The review of historical maps provided information about changes to the site and its surroundings between 1881 and 2016.

Figure 3 – Extracts from Historical Ordnance Survey Maps between 1881 and 2016

The review of historical maps provided information about changes to the site and its surroundings, between 1881 and 2016. In 1881 the majority of the site was shown as open land, with areas of trees and small unidentified buildings. In 1923 a road is shown passing through the site, with a timber yard operating in the north. A slaughter house is shown in the north of the site on the 1965 to 1974 map. In the 1972 to 1982 map, allotment gardens are present in the south of the site. From 1982 until the present day, the Icon office complex is present on site.

The surrounding area has become increasingly developed from 1881 to the present day. In 1881 the surrounding area to the south, west and northwest is shown primarily as open land with residential development to the east and northeast, increasing residential development in the south and west is noted from 1946. Industrial usage to the south and southwest increases from 1962, with factories and works present.
